Town Branch Urban Trail  
Riparian Evaluation Project  
Monitoring Quality Assurance Project Plan  
(QAPP)  
Contract No. 18-80212

City of Lockhart  
308 W. San Antonio St.  
Lockhart, Texas 78644

Nonpoint Source (NPS) Program CWA §319(h)  
Prepared in cooperation with the Texas Commission on Environmental Quality  
and the U.S. Environmental Protection Agency  
Federal ID # 99614622  
QTRAK # \_\_\_\_\_

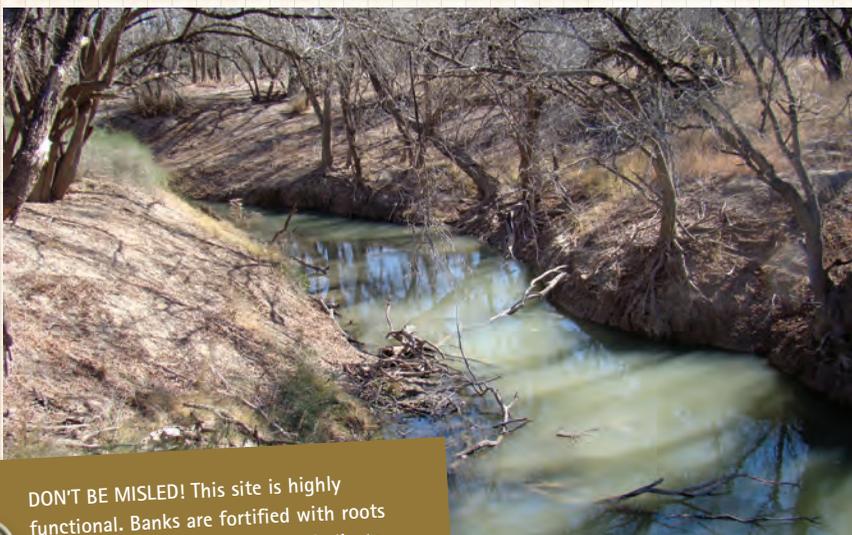
# FUNCTIONAL

**DON'T BE MISLED!** This site is highly functional. Banks are fortified with roots and anchored large wood. Signs indicate the floodplain is accessed regularly, and it contains plenty of energy dissipation.

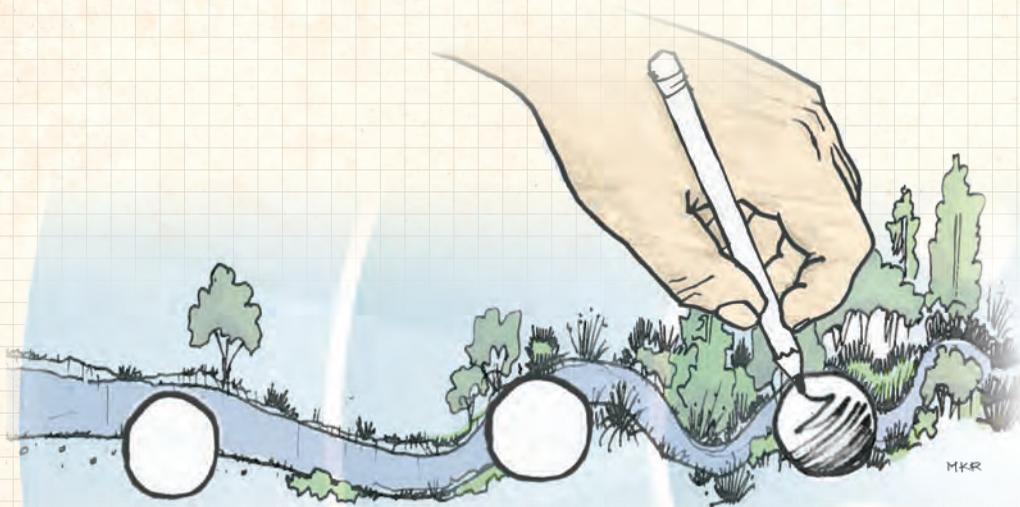
The bull's-eye area in the center of the target represents optimal function and the outermost ring of the target represents dysfunction. The middle ring of the target represents an at-risk condition, a kind of riparian health danger zone.

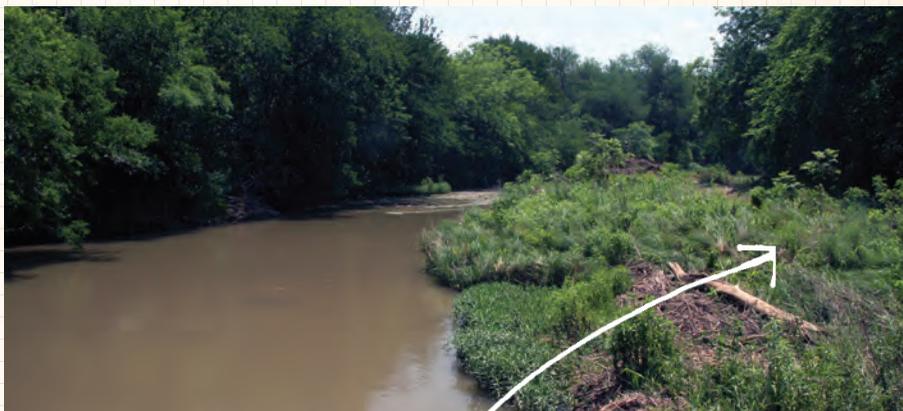
Good floodplain access

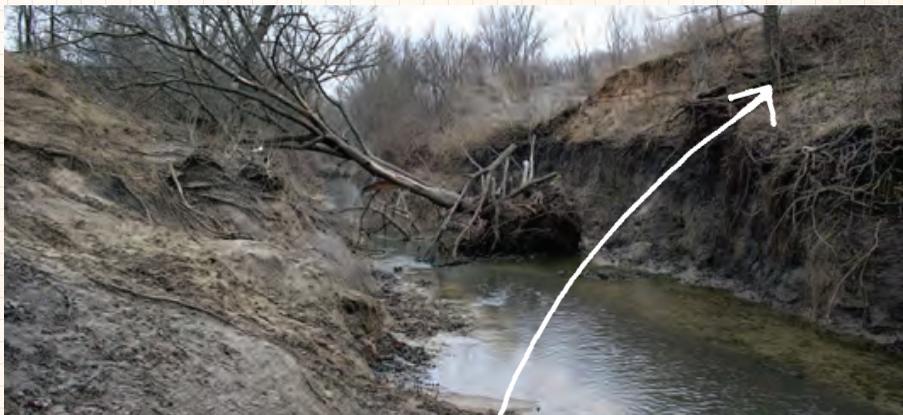
Floodplain is not very accessible

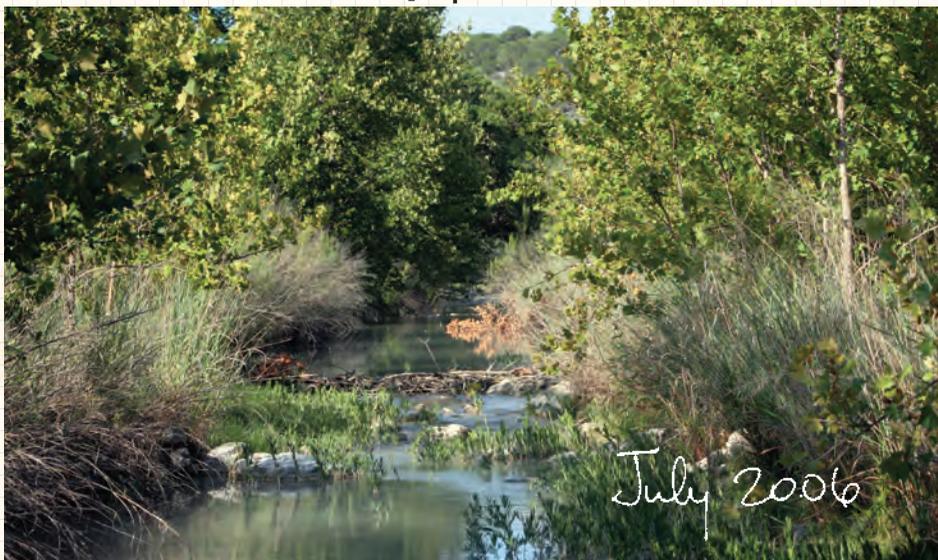
Good energy dissipation

The above photos are of the same riparian site. Only a few energy-dissipating features remain in 2015. Often, well-meaning but uninformed landowners clear key riparian features in a misguided effort to "help" the creek.

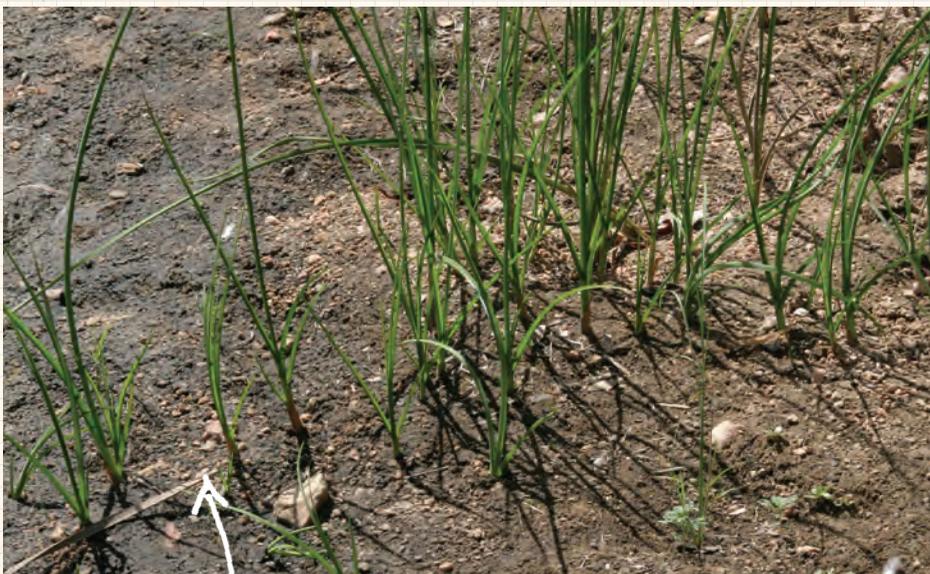
plants colonizing fresh sediments

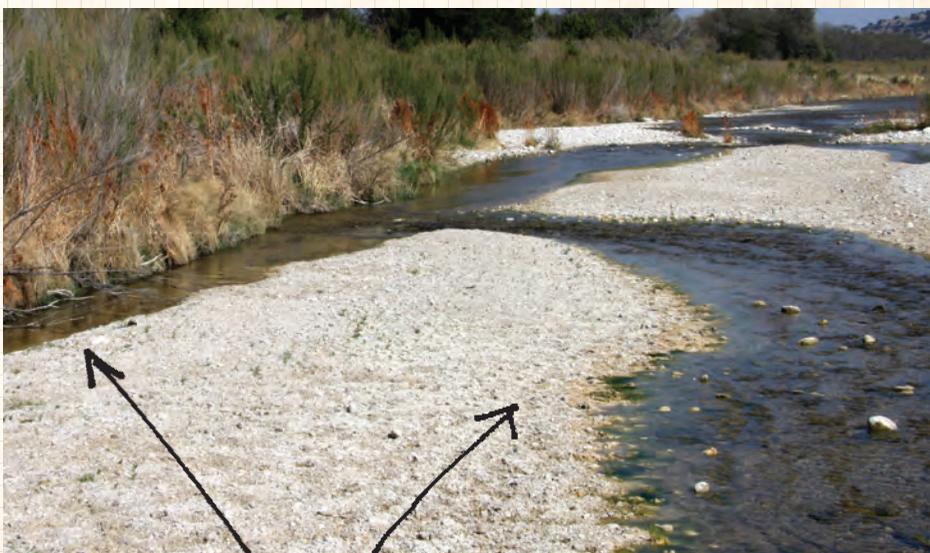
No new plant colonization here

No new plant colonization is visible on the point bars along this creek. Looking closely can usually reveal why; something may be hindering new plant colonization.  
Photos courtesy of Steve Nelle.

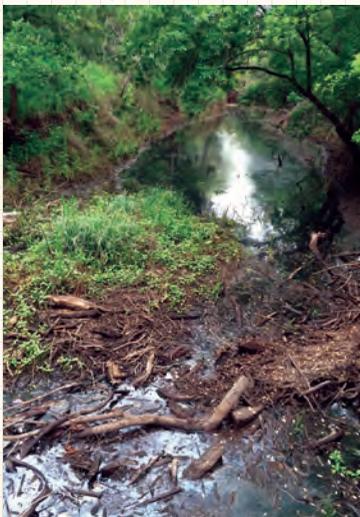
San Miguel Creek, Frio County  
Mexican ash, SR6  
Wafer ash, SR5/6  
Plus large wood

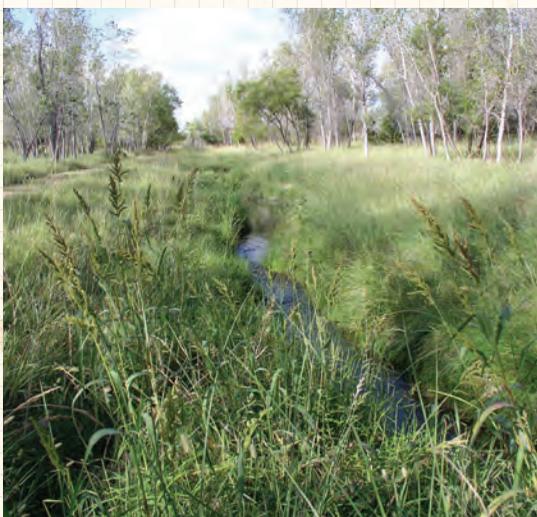
Lelia Lake Creek, Donley County  
Bulrush, SR8/9  
Indian grass, SR7  
Spikerush, SR6  
Switchgrass, SR8/9

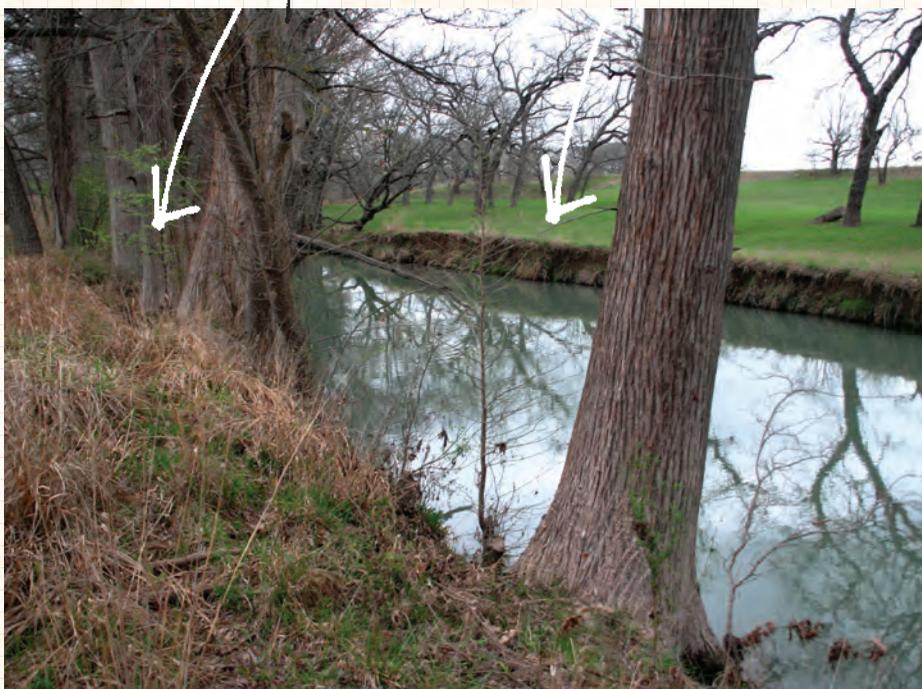
No age diversity

Age diversity of riparian plants is an indicator of health. Plants of different ages can help provide stability during fluctuations in flow and climatic conditions. The presence of both young and old palatable plants can indicate that past and present grazing and browsing have not hindered function.

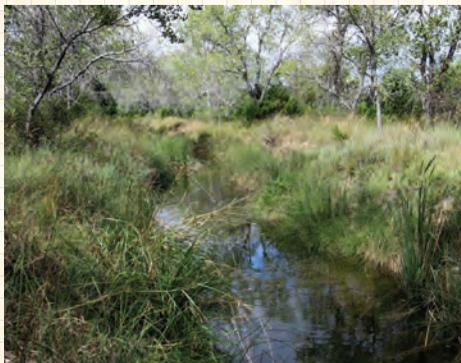
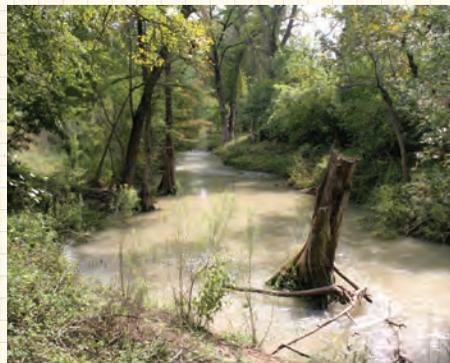
*Good species diversity*

Good plant diversity on a Canadian River tributary in the Rolling Plains on the eastern side of the Texas Panhandle.

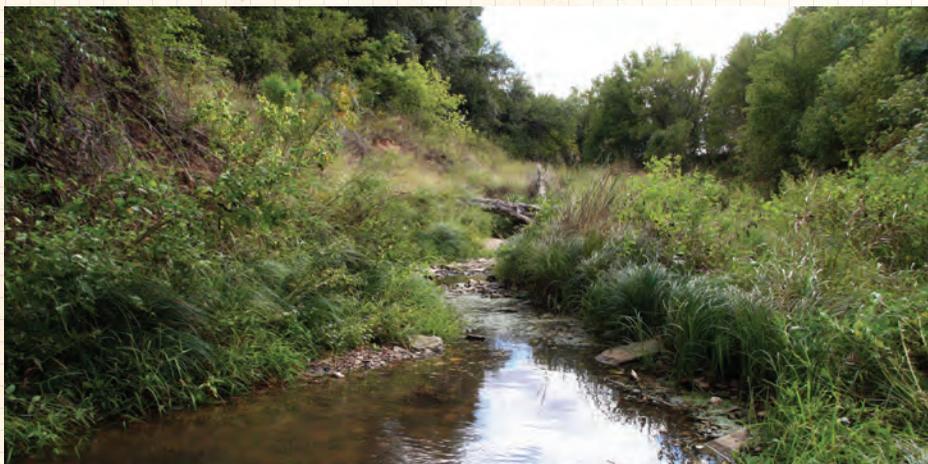
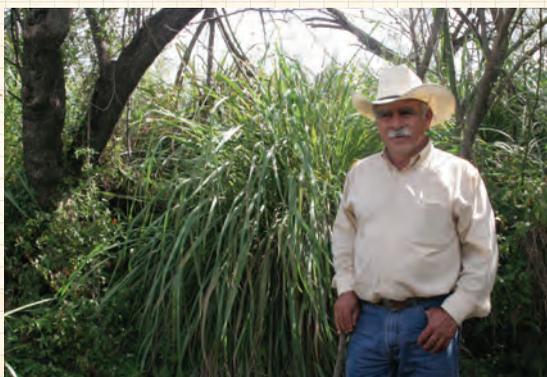
Good plant vigor

Many of the plants shown in these images are palatable grazing and browsing species, yet there are no signs that vigor is impaired by humans or animals. Some of these locations are used for occasional livestock grazing, but with proper management, riparian plant vigor has been maintained. Photos courtesy of Steve Nelle.

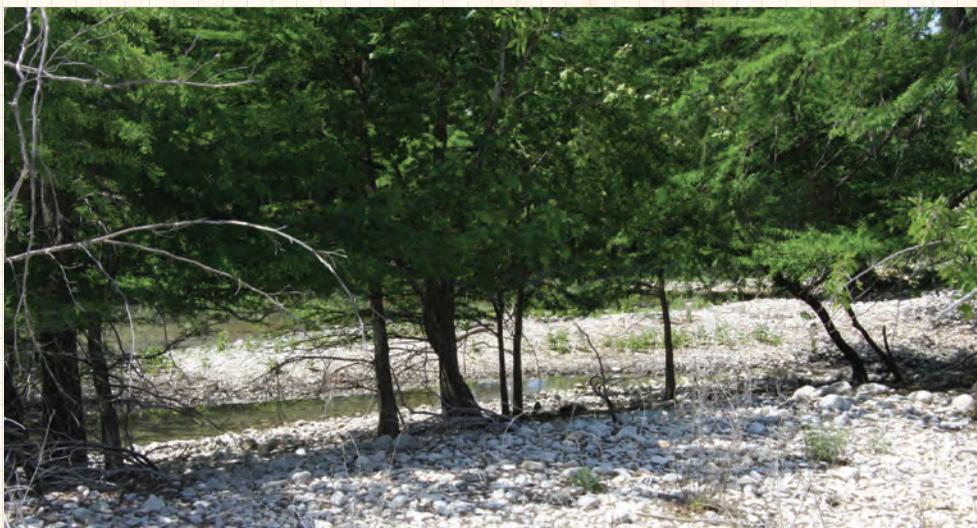
This image shows a distinct browse line on riparian trees, indicating a vigor problem. While these trees appear to be healthy, when their trunks are exposed from browsing, their flood resilience is weakened.

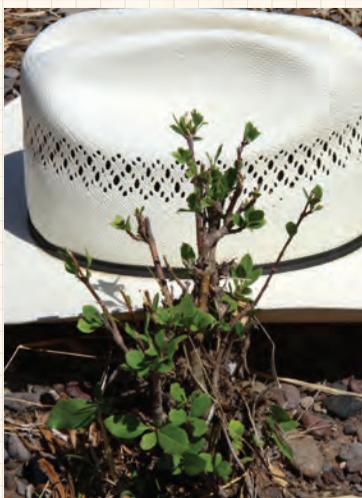
Buttonbush, a highly palatable browse plant, is pictured here with signs of heavy and long-term browse.

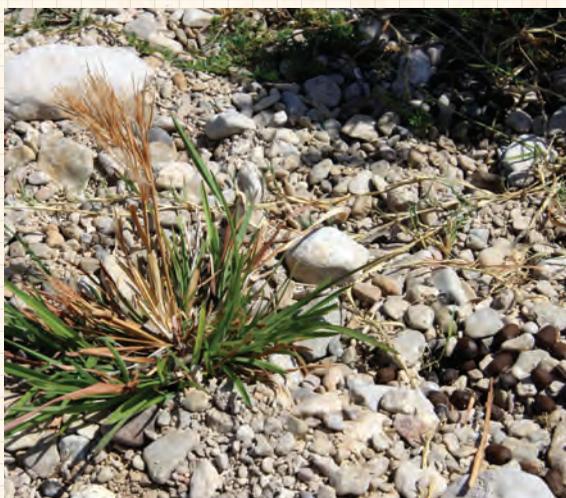
Bushy bluestem, a moderately palatable grass, shows signs of extreme overgrazing, perhaps by axis deer.

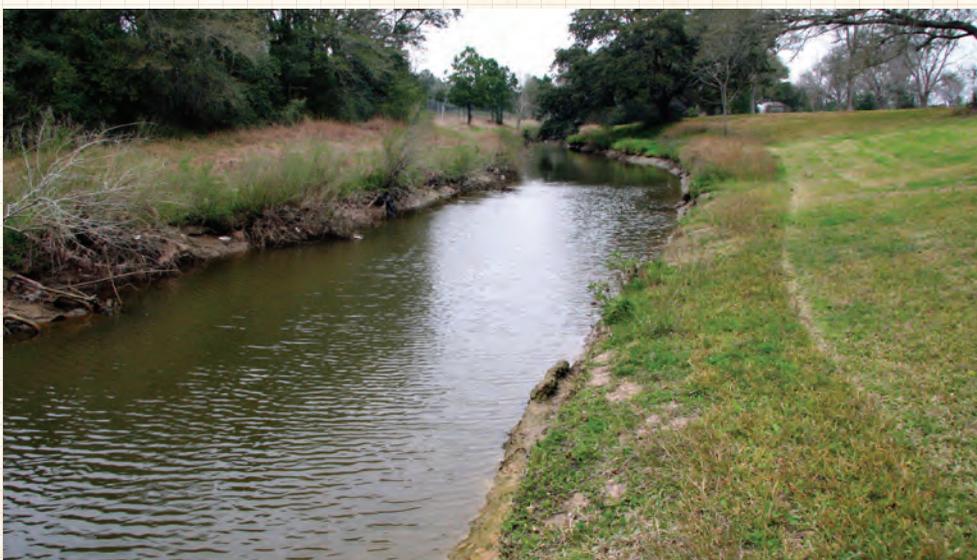
Riparian grasses in this image are vigorous on one bank and impaired by mowing and weed-eating on the opposite bank.

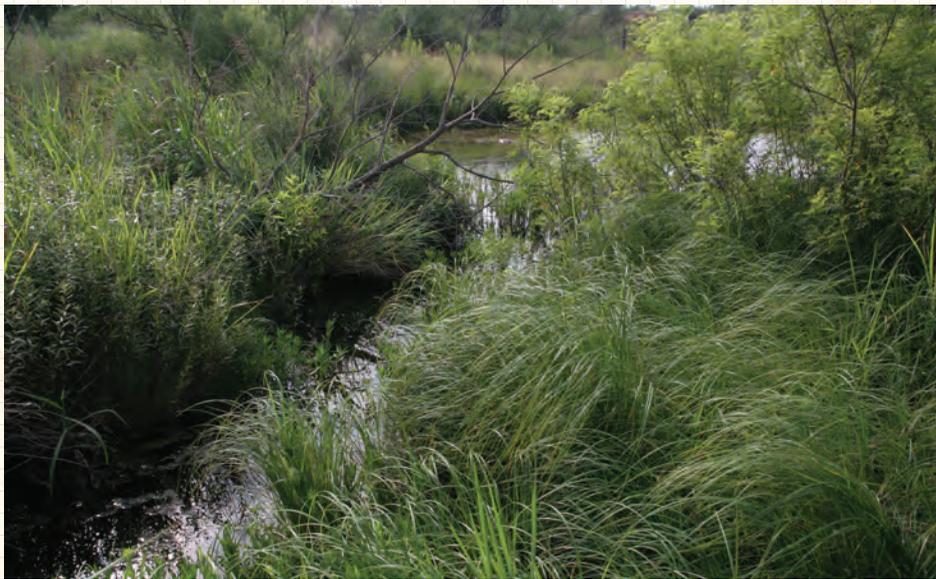
*Good water storage*

Good water storage capacity is shown by the presence of:  
Black willow (FACW)  
Emory sedge (OBL)

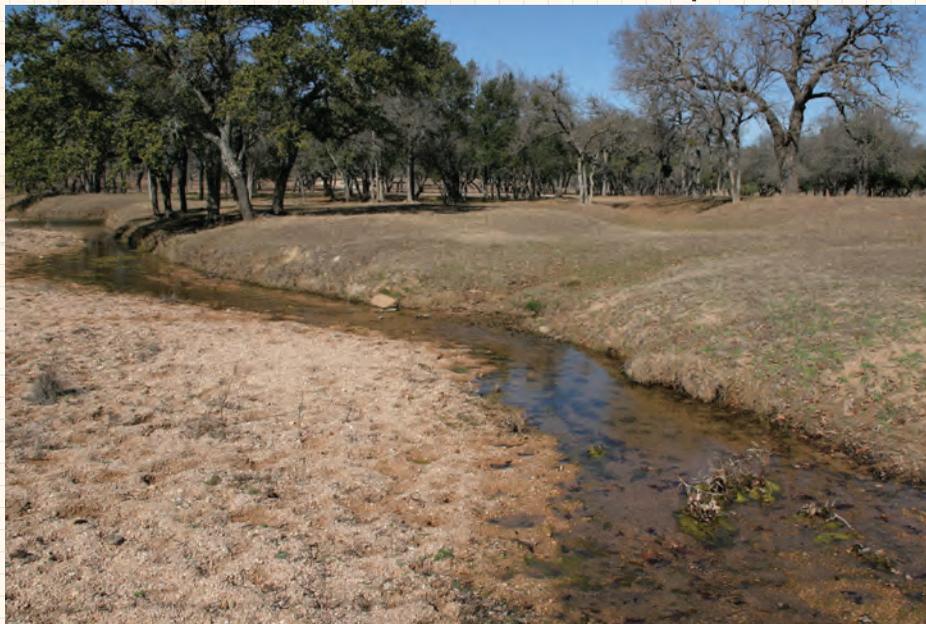
*No water storage*

This photo shows upland species in the riparian area:  
Live oak (FACU)  
KR bluestem (UPL)

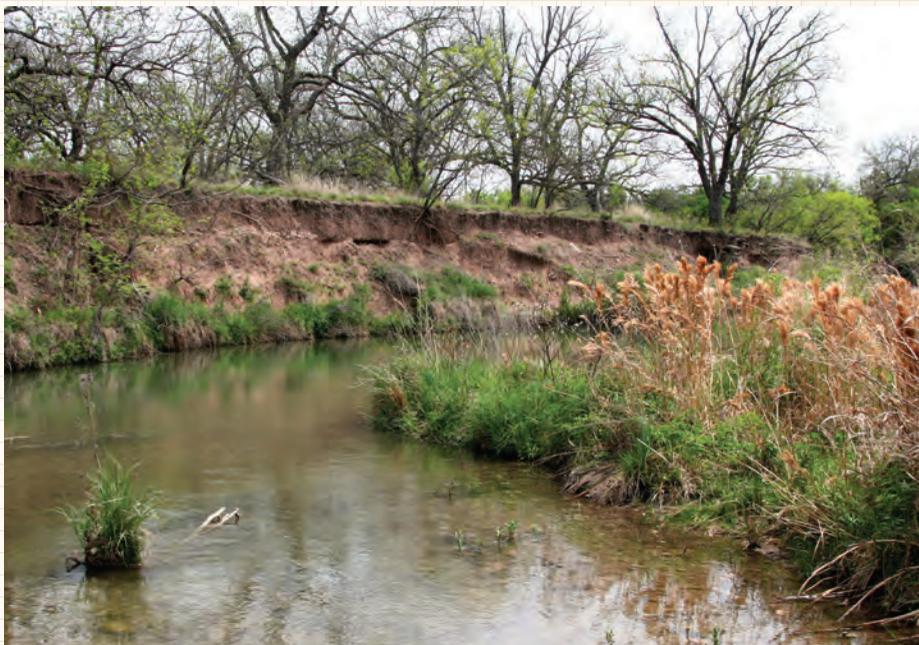
Balanced

Look for signs of bank or channel erosion. Is it in predictable locations on meander bends where point bars are being formed with the eroded material just downstream? Does the channel look down-cut, or incised like a drainage ditch? If so, it may also lack an active floodplain.

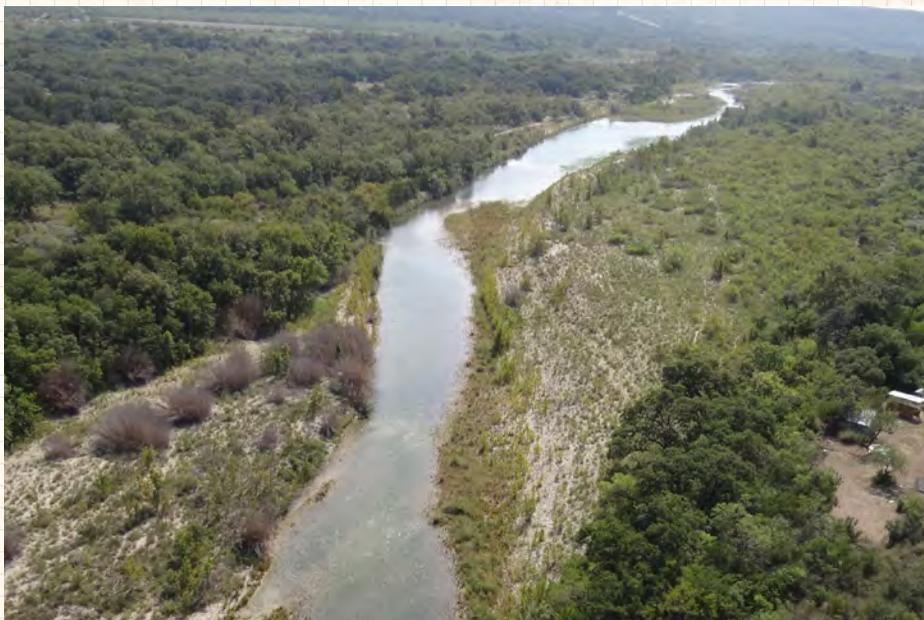
*Sediment deposition balanced*

Nueces River, Uvalde County, 2012

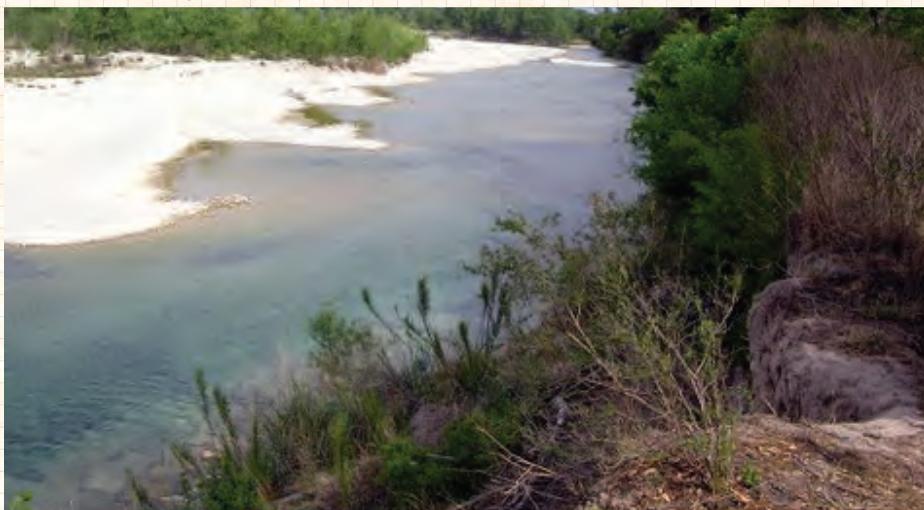
*Sediment out of balance*

Nueces River, Uvalde County, 2007. Photos by Sky Lewey.

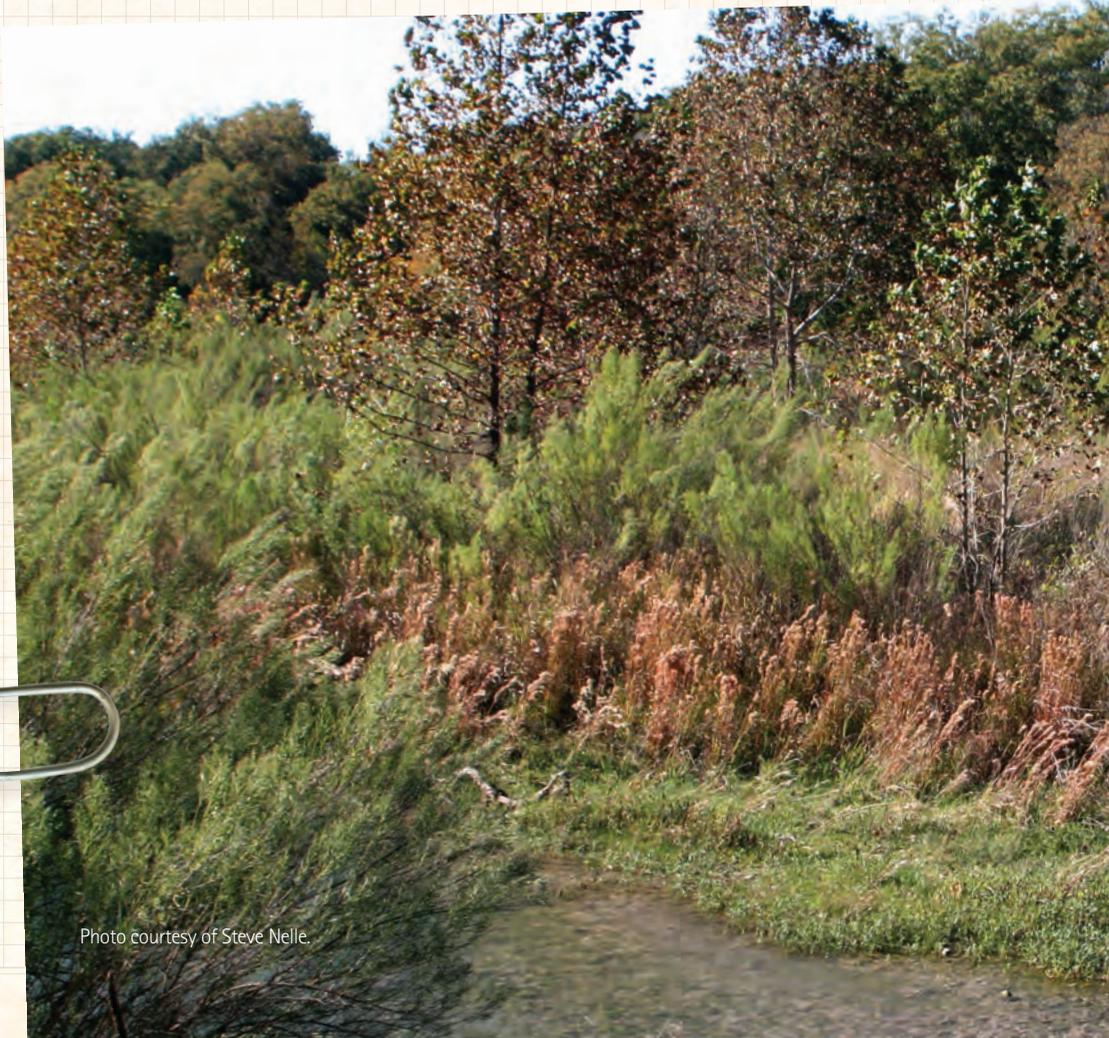
- 1 Floodplain clearly defined and accessible. If you look closely you can see bits of flood debris.  
**Inner Zone, Bull's-Eye**
- 2 Only some energy dissipation along the bank and in the channel, but abundant energy dissipation in floodplain.  
**Inner Zone, Bull's-Eye**
- 3 Abundant colonization of fresh sediment (water willow and spikerush).  
**Inner Zone, Bull's-Eye**
- 4 Some gaps in coverage of stabilizing plant communities (not well enough established yet). **Mid-Zone, At-Risk**

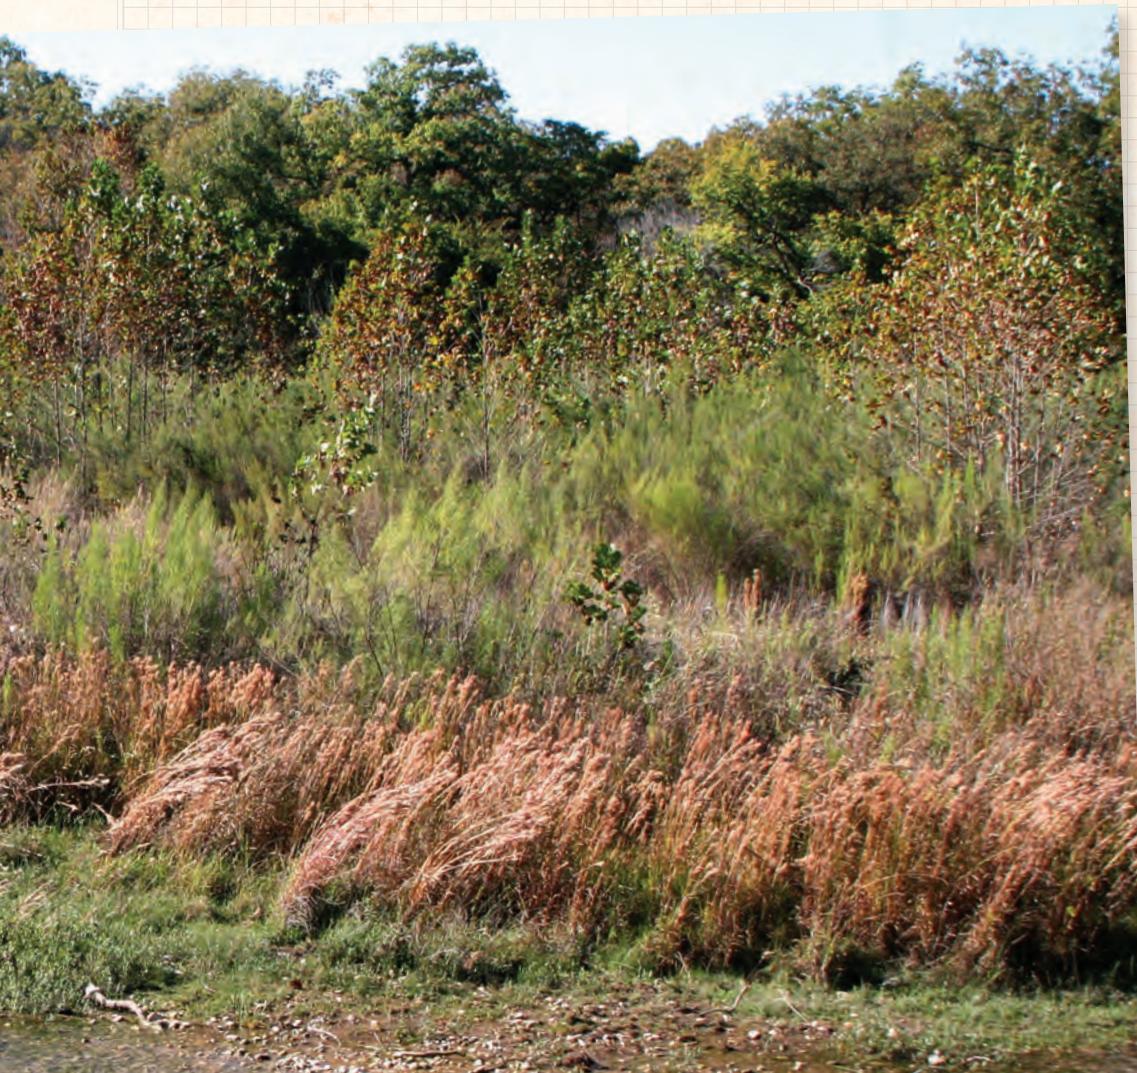
- 5** Abundant reproduction of woody plants (baccharis and sycamore) and/or grasses and sedges (spikerush and bushy bluestem). **Inner Zone, Bull's-Eye**
- 6** Modest diversity of woody plants (baccharis, sycamore, button bush) and modest diversity of grasses and sedges (only four are visible). **Mid-Zone, At-Risk**
- 7** Woody plant vigor not readily apparent in the photo, but herbaceous plant vigor appears healthy and vigorous. **Inner Zone, Bull's-Eye**
- 8** OBL and FACW species, indicating water storage, are abundant near the water's edge, but not further back. **Mid-Zone, At-Risk**
- 9** No excessive bank erosion is visible in the photo. **Inner Zone, Bull's-Eye**
- 10** Sediment appears normal and balanced in the photo. **Inner Zone, Bull's-Eye**
