Operation and Maintenance Plan for Town Branch Creek Riparian Areas

Water Body: Town Branch Creek (Segment 1810A), a tributary to Plum Creek
Grantee: City of Lockhart, Texas
Subgrantee: Nueces River Authority (NRA)
TCEQ Contract No: 18-80212
Report Date: August 1, 2020

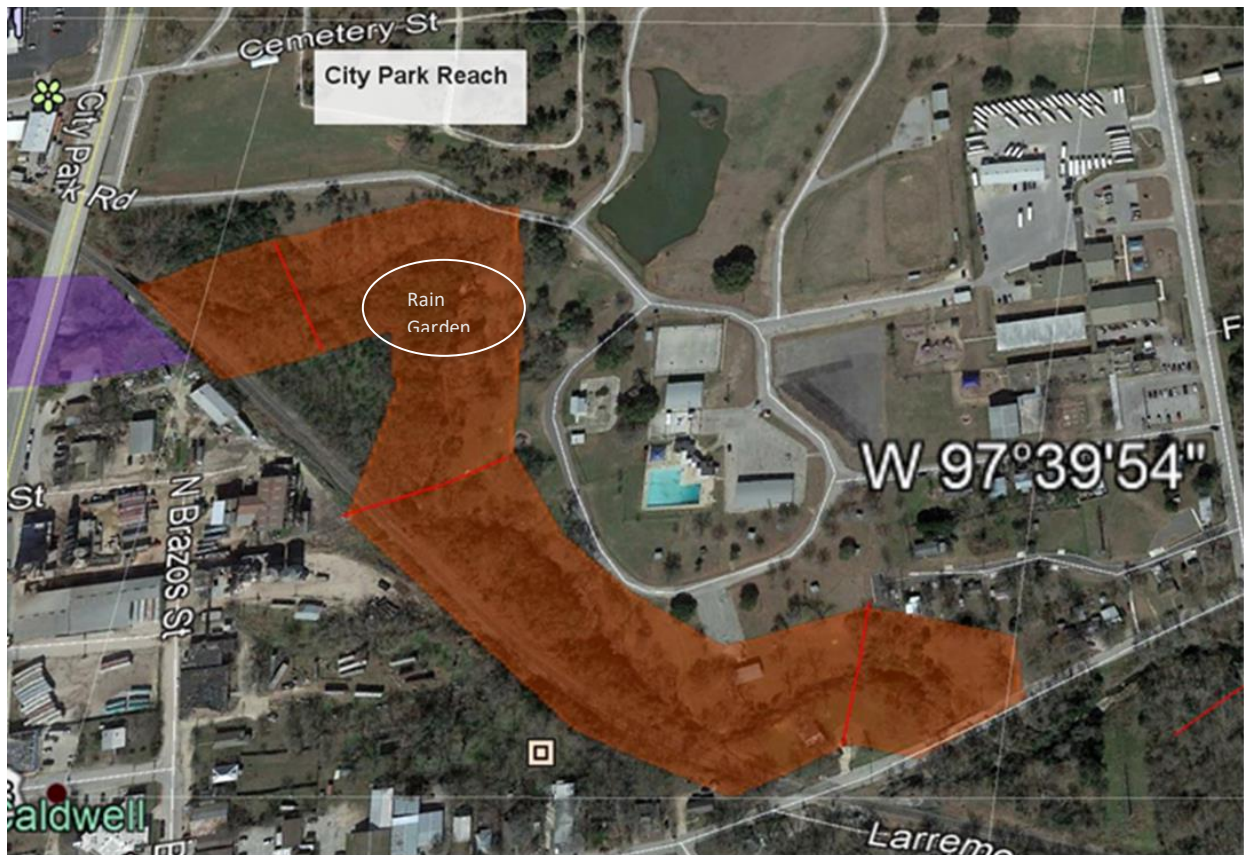
Fig 2. Google Earth[™] image of the Riparian Area of Town Branch Creek's City Park Reach highlighted in orange and the rain garden site identified.

Within the City Park Reach, as recommended a rain garden has been established to temporarily capture and slow runoff from uplands allowing a slower release of stormwater through heavily vegetated riparian areas. Within both reaches, a mowing setback was used to create grow zones that then were augmented by the planting of riparian grasses.

In 2019, the City began implementing BMP's to address identified hinderances. A "grow zone" mowing setback was established along the creek encompassing about 2.43 acres and in 2020, a rain garden was installed to slow runoff from a highly altered area of uplands. Additionally, native riparian vegetation was planted at key sites to help accelerate the recovery process.

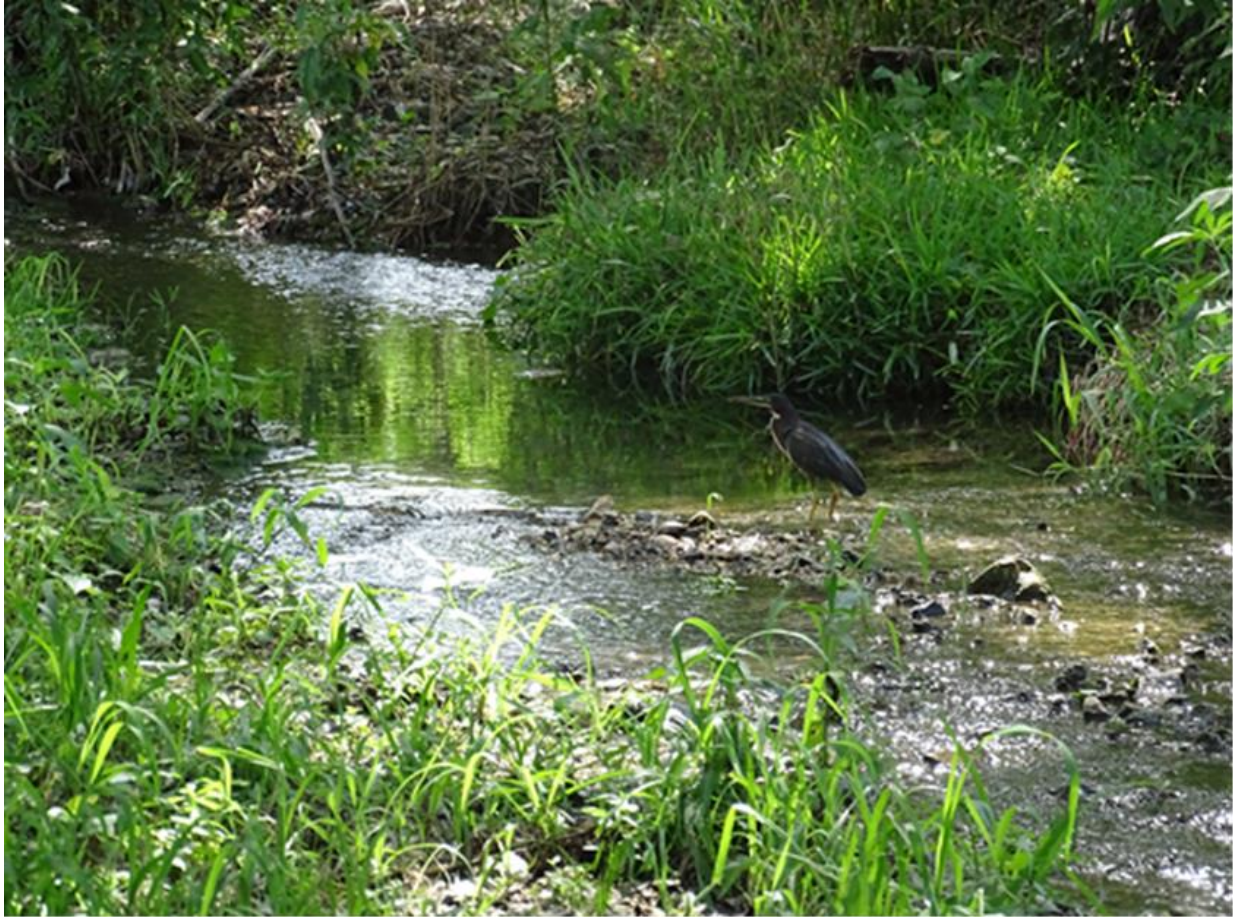
Fig 4. Heron loafing in Town Branch Creek within the City Park Reach. Riparian vegetation in the foreground is beginning its recovery as part of the mowing cessation plan.

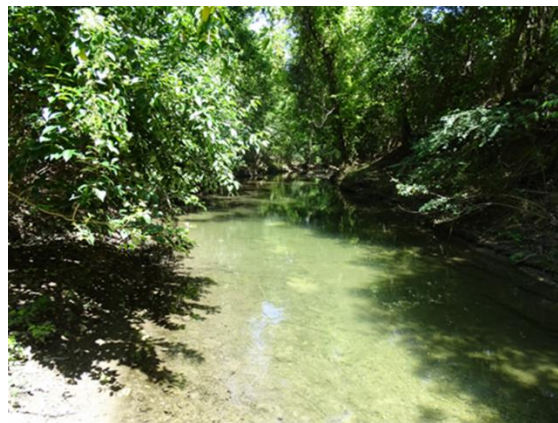
Fig 5. Clear water and well vegetated banks in Town Branch Creek downstream of the BMP implementation.
