Rain Garden As-Built Report: Town Branch Creek

Water Body: Town Branch Creek (Segment 1810A), a tributary to Plum Creek
Grantee: City of Lockhart, Texas
Subgrantee: Nueces River Authority (NRA)
TCEQ Contract No: 18-80212
Report Date: June 1, 2020

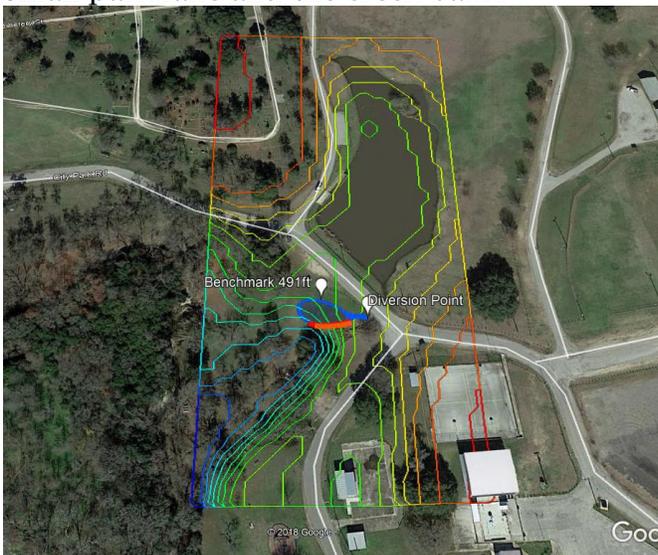
Fig 1. Google Earth™ image of the City Park Rain Garden site with topographic contours overlain and diversion point and garden site identified.

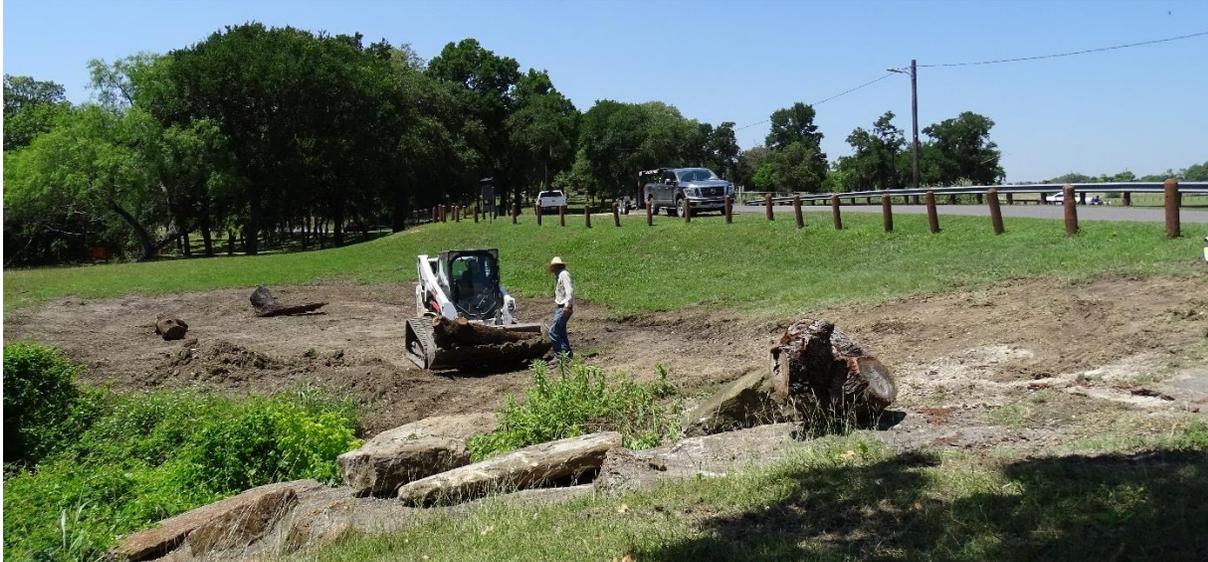
Fig 3. Rain Garden site with City contractor preparing the “bowl” and placing large wood and rock to divert approx.. 30% of flow from the drain into the garden area.

The City’s equipment contractor made cuts and fills aimed at constructing a stable, compacted berm with near perfect level, uniform consistency while leveling the garden floor to contain and spread diverted stormwater. Care was taken to hold constructed elevations while creating and producing the final grades. The site was then scarified and raked to final grade. Large dead trees and large rocks were used to create and anchor a diversion from the nearby drain. NAS personnel installed turf matting and riparian plants and seeds. When the garden site was finished City staff began immediately providing supplemental water and a few days afterward approx.. 4 inches of rain fell and the first runoff event occurred which filled the rain garden and offered insight into how it will function.

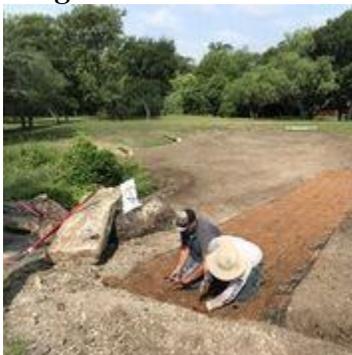
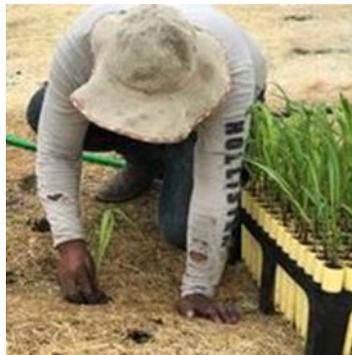
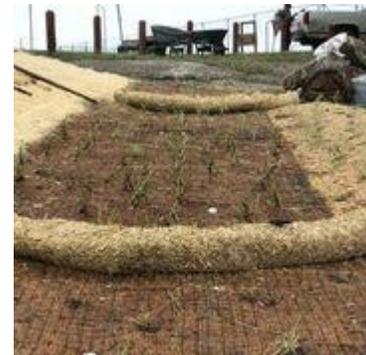
Fig 4. A form of turf matting was installed, and riparian plants were plugged into the fabric.

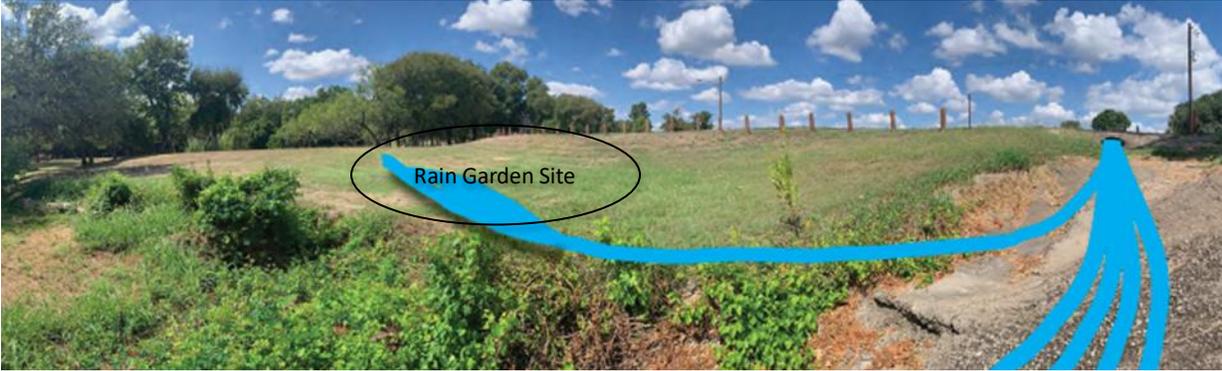
Fig 5. Shows the drain way at the diversion point as designed.

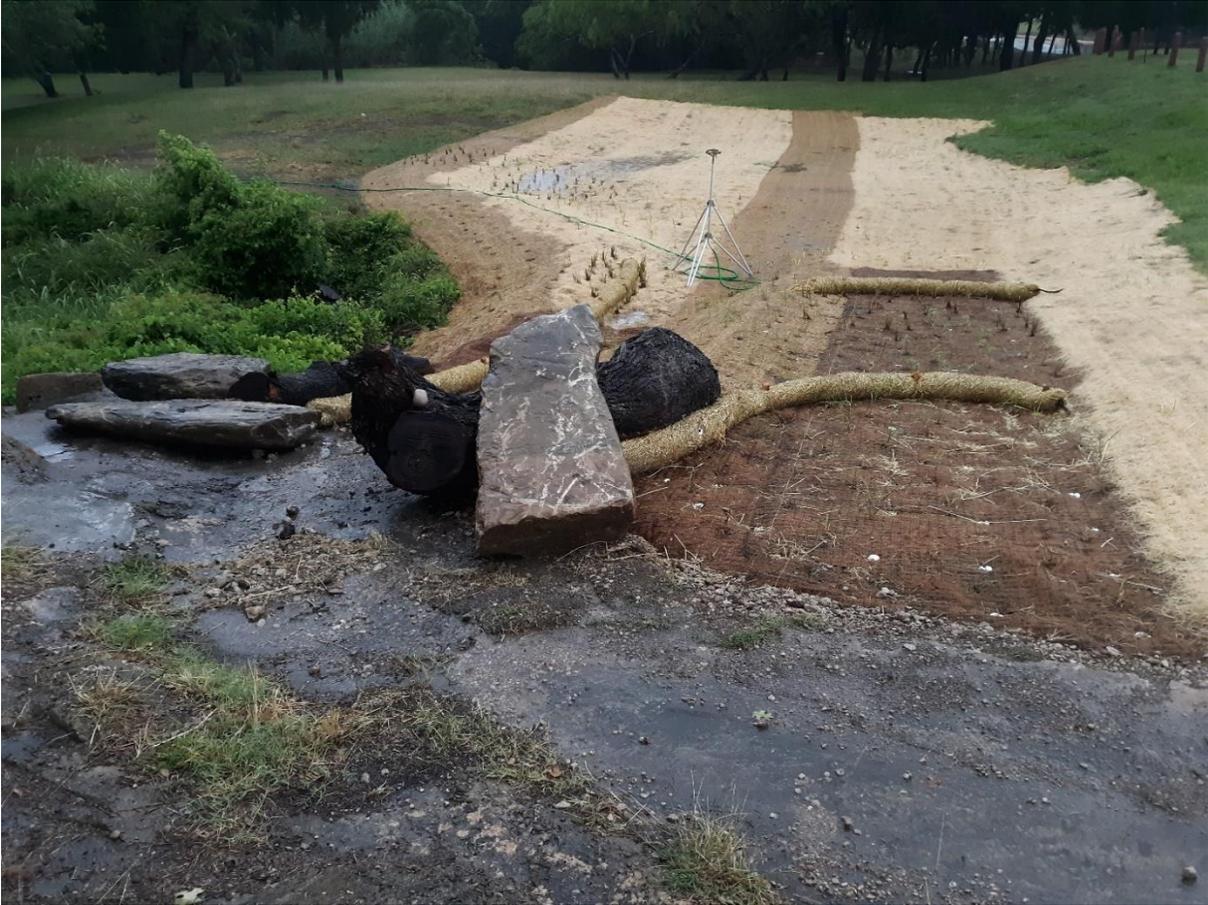
Fig 6. Rain garden diversion point as built.

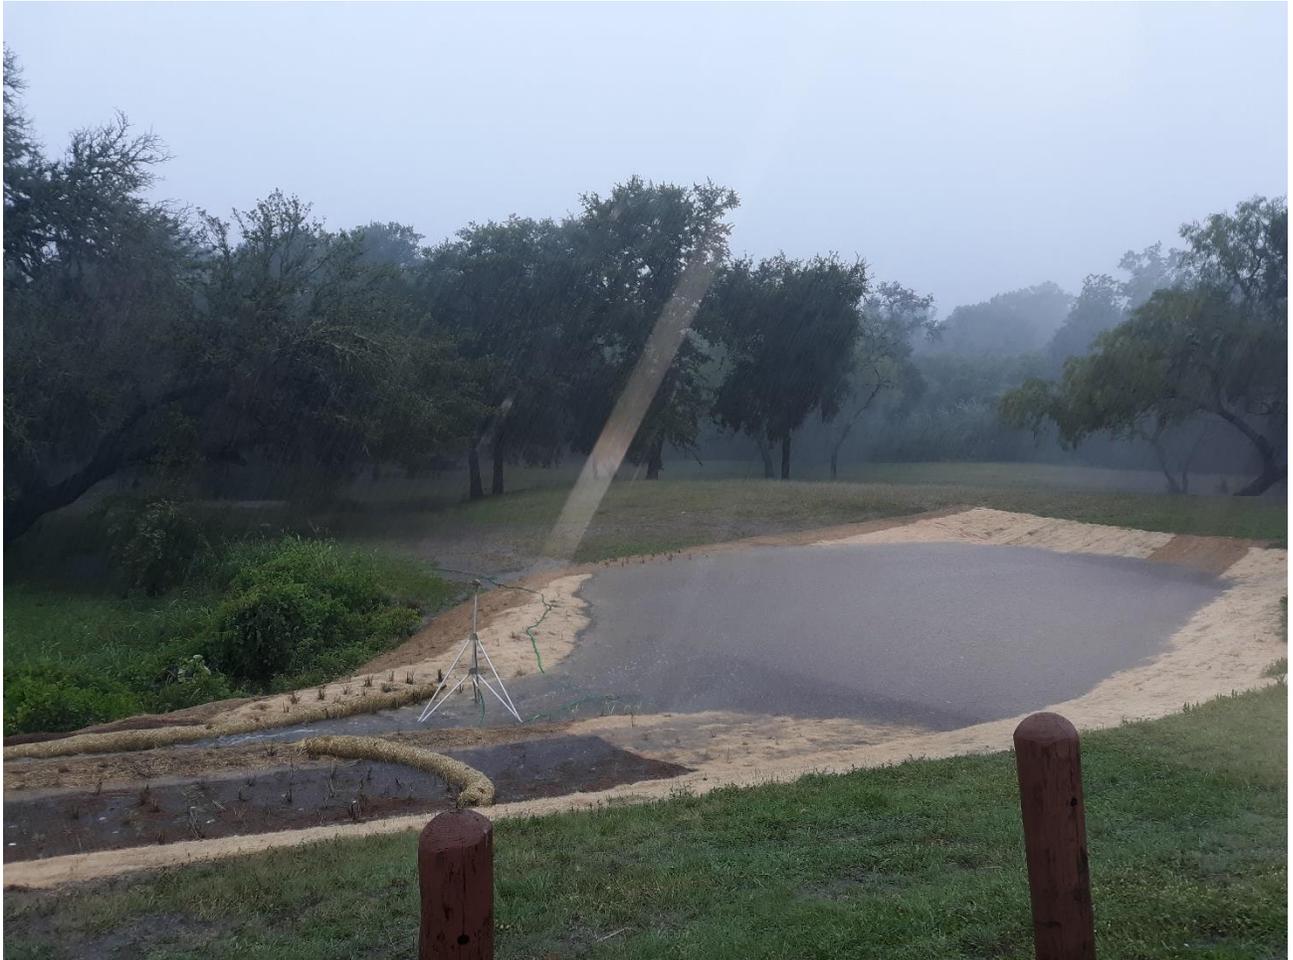
Fig 9. A few days after installation a 4 inch rain fell and City staff captured this image showing approx. 1/3rd of the flow from the conduit being diverted into the garden. Slow overtopping occurred, as expected, along the downslope edge of the bowl. Once the planted vegetation has developed this area is expected to become more and more stable further slowing over-topping while trapping floating debris.
