# Riparian BMP As-Built Report: Town Branch Creek

**Water Body:** Town Branch (Segment 1810A), a tributary to Plum Creek  
**Grantee:** City of Lockhart, Texas  
**Subgrantee:** Nueces River Authority (NRA)  
**TCEQ Contract No:** 18-80212  
**Report Date:** June 1, 2020

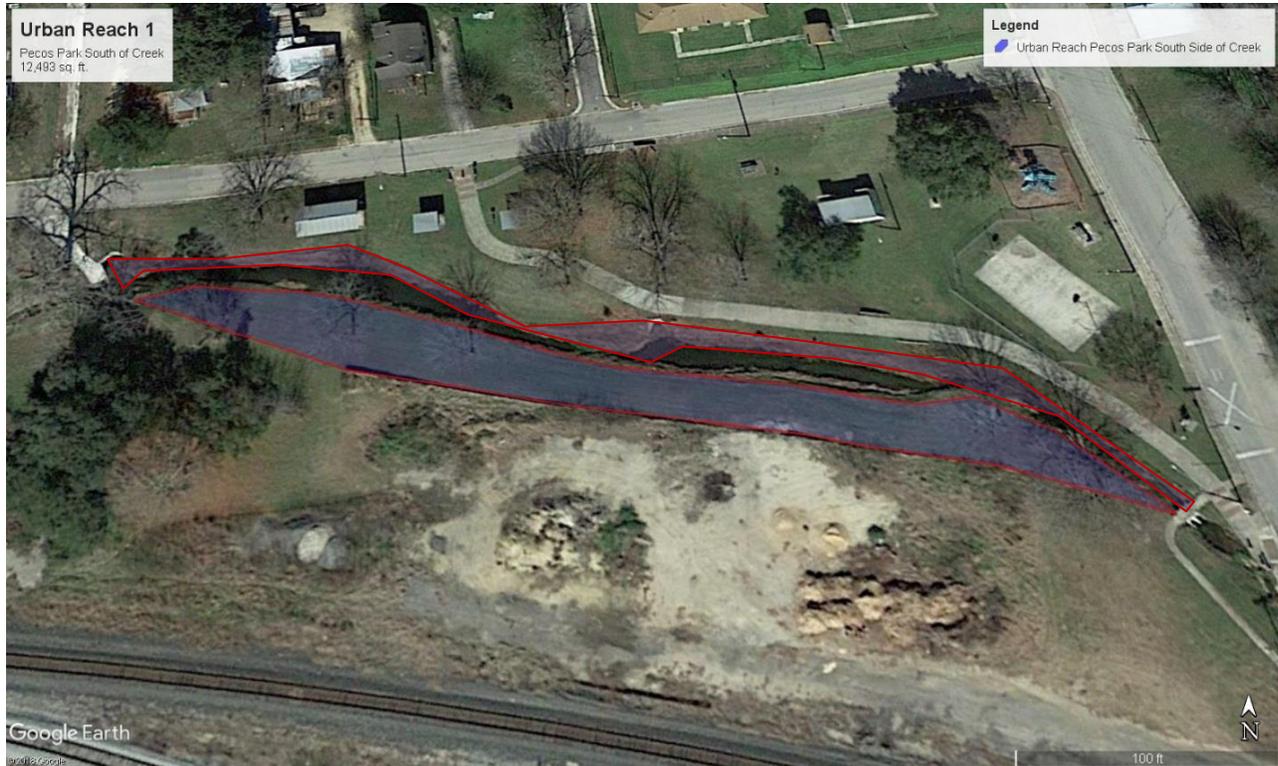
## UR 1 Pecos Park South

*Fig 3. Google Earth<sup>™</sup> image of the UR1 mowing setback grow zone highlighted in purple.*

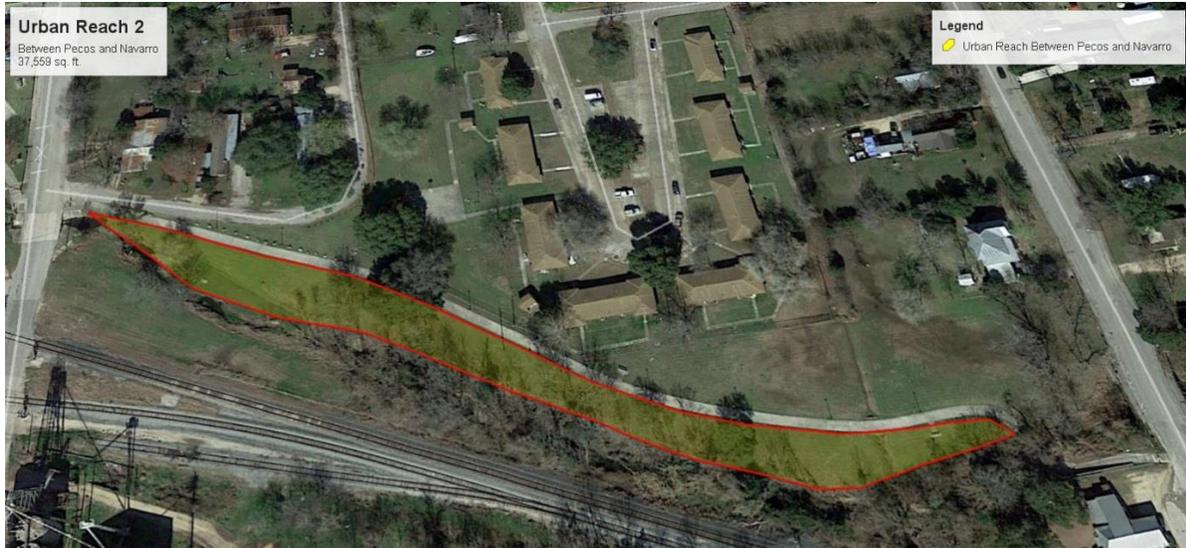
## UR 2 Pecos to Navarro

*Fig 4. Google Earth<sup>™</sup> image of the UR2 mowing setback grow zone highlighted in yellow between Pecos and Navarro Streets.*

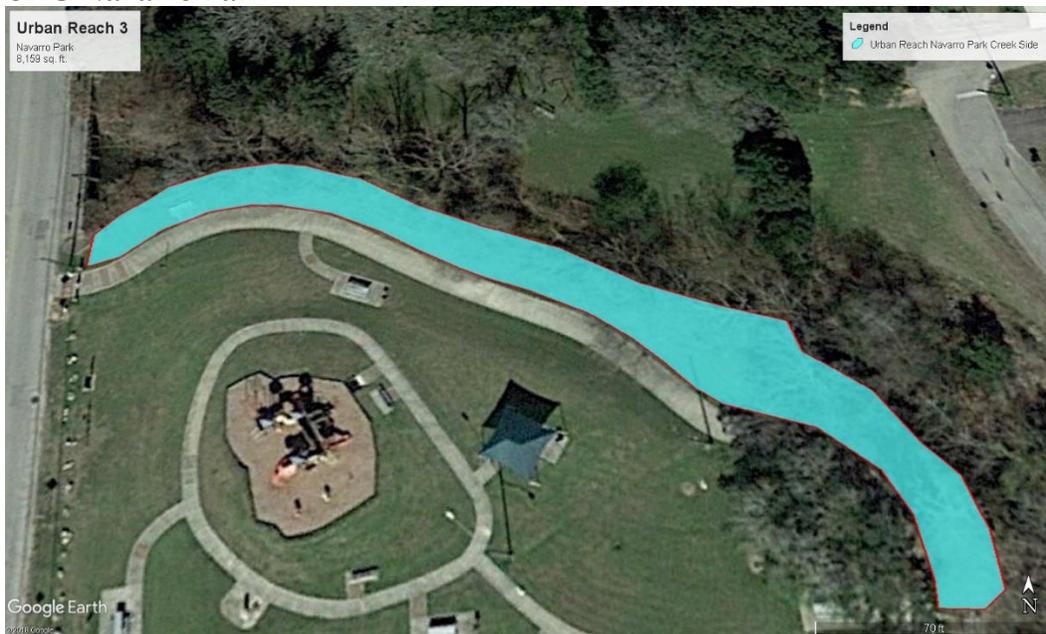
### UR 3 Navarro Park

*Fig 5. Google Earth<sup>™</sup> image of the UR3 mowing setback grow zone highlighted in blue within Navarro Park.*

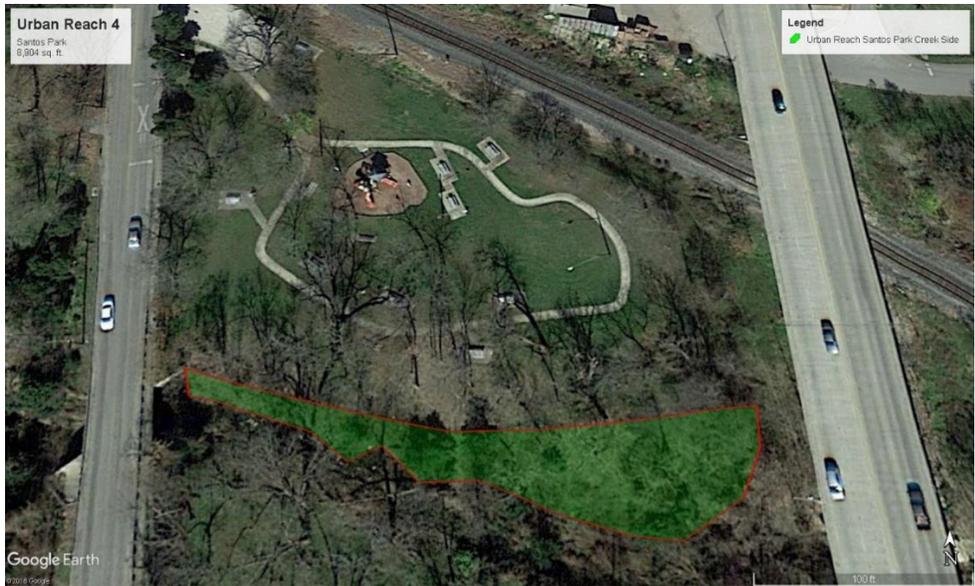
### UR 4 Santos Park

Fig 5. Google Earth<sup>tm</sup> image of the UR4 mowing setback grow zone highlighted in green within Santos Park.

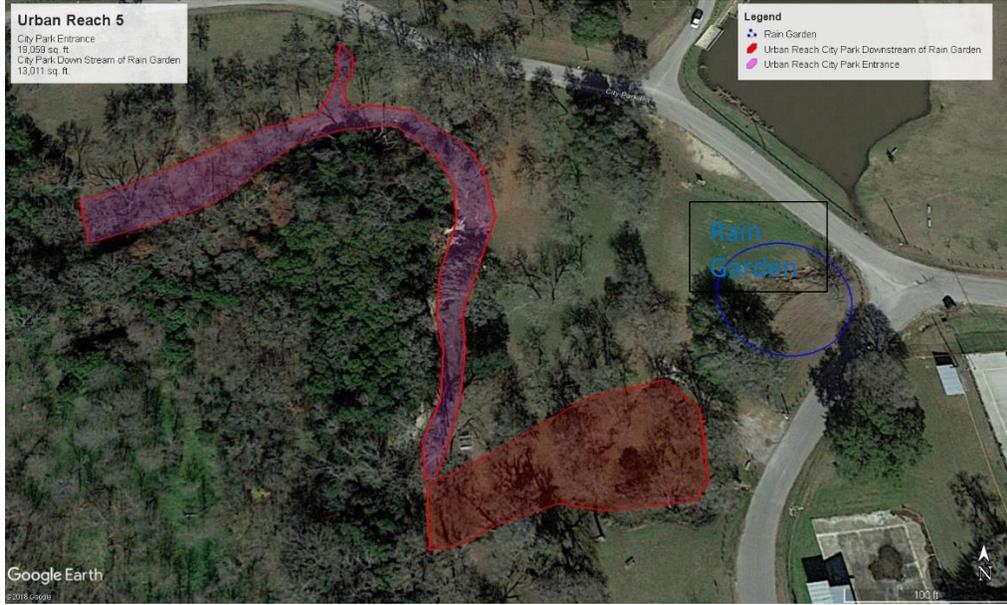
UR 5 City Park Entrance and Tributary Drains

Fig 6. Google Earth<sup>tm</sup> image of the UR5 mowing setback grow zone highlighted in red and purple in the entrance area of the City Park and along tributary drain ways.

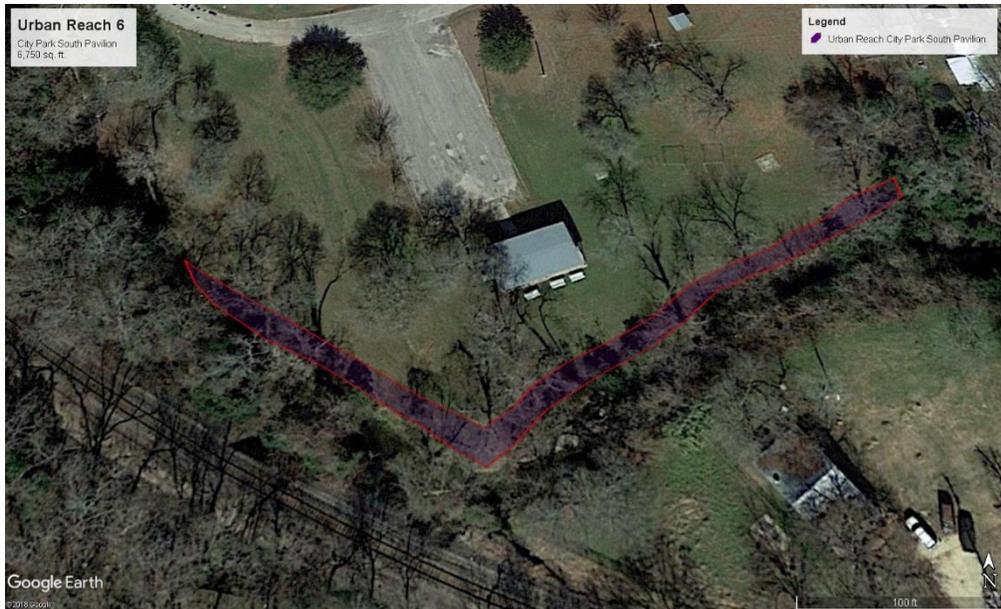
UR 6 City Park South Pavilion

Fig 7. Google Earth<sup>tm</sup> image of the UR6 mowing setback grow zone highlighted in purple along the creek in south pavilion area of the City Park.

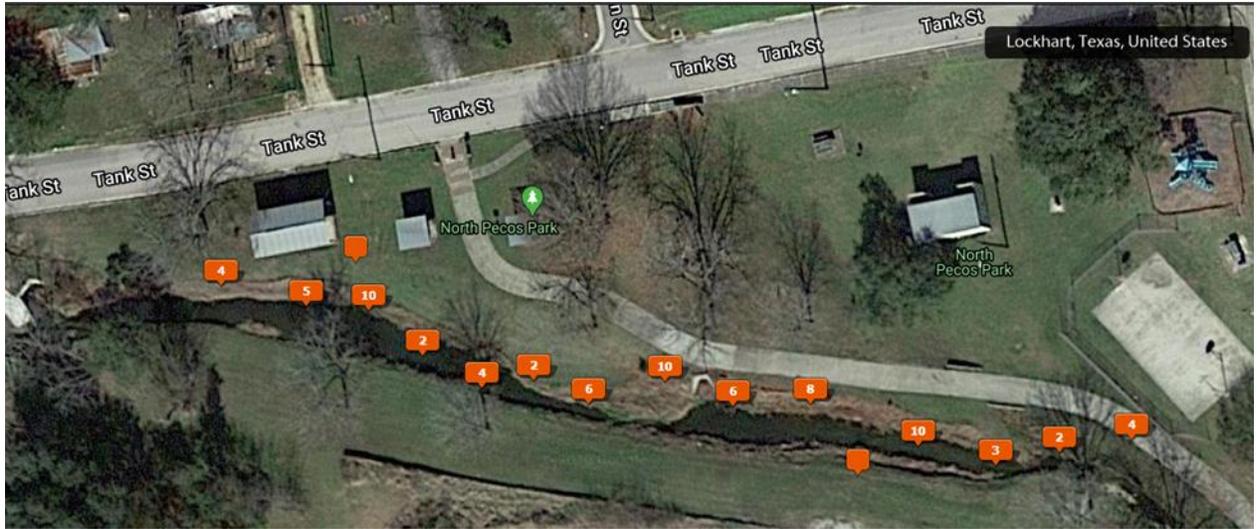
Fig 8. Google Earth<sup>tm</sup> image of the approximate planting sites for Eastern gamma and Switchgrass plants within the UR1 Pecos Park area.

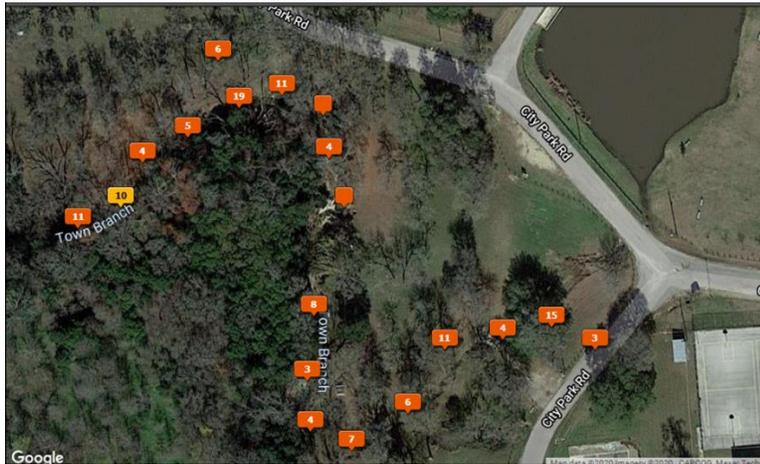
Fig 9. Google Earth<sup>tm</sup> image of the approximate planting sites for Eastern gamma and Switchgrass plants within the UR5 City Park area.
